Inspection Report

**Mr. & Mrs. Sample Report
1449 Sample Report Drive
Clearwater, FL 33756**

Prepared by: **Bay Area Building Inspections, Inc.**

RE: 1449 Sample Report Drive
Clearwater, FL 33756

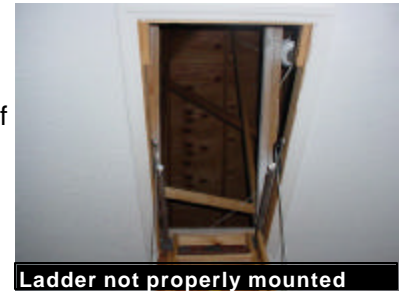
The attic ladder in the garage was found not properly installed as the ladder framing was found installed with drywall screws. Drywall screws are not designed to support the weight of the ladder with someone climbing on it. Typical number #16b nails are required to be installed. Suggest inquiring with insulation instructions to ensure proper supports. Ladder could be a safety hazard as ladder could fall.

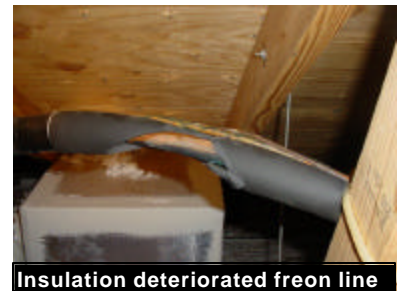
The insulation wrapping on the freon line running through the attic was found split apart at the taped seams. This condition is allowing condensation to build up on the freon line and drip down onto the attic insulation will in time stain the ceiling.

Insulation deteriorated freon line

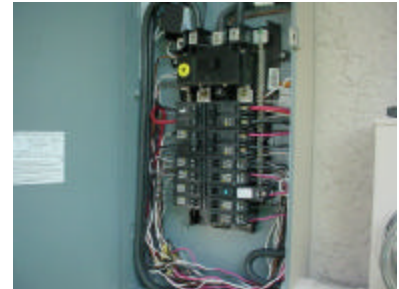
Multiple wires are connected to a single lug on a circuit breaker where only one wire should be connected. Circuit breakers having double leads, or connection of more than one wire to each circuit breaker indicates more circuit breakers are needed to accommodate the appliances in the house.

Circuit and wire sizing correct so far as visible, Grounding system is present, Anti oxidant recommended on aluminum 220 volt and or 110 volt connections. Good electrical practice dictates that stranded aluminum wiring be installed with the use of anti-oxidant paste, applied to the exposed ends of wiring and provided to prevent the formation of nonconductive aluminum oxide. While no signs of overheating or problems are evident at this point in time, you should request your electrical apply some to the above mentioned wires the next time he is called out for other work.
