Inspection Report

**Mr. & Mrs. Sample Report
1449 Sample Report Drive
Clearwater, FL 33756**

Prepared by: **Bay Area Building Inspections, Inc.**

RE: 1449 Sample Report Drive
Clearwater, FL 33756

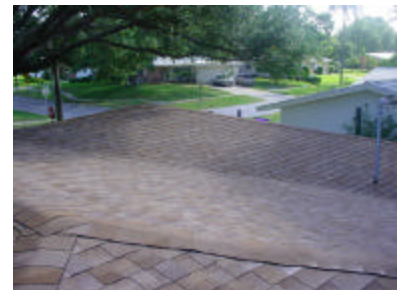
Walked on roof.

Appears serviceable/within useful life, General condition appears serviceable with signs of weathering/curling and aging. Regular maintenance and inspections are advised.
